*Plum Creek Timber Company
Native Fish Habitat Conservation Plan*

**1997 - Thompson River
Riparian Reconnaissance and Monitoring**

**Scott L. Miles
Riparian Resources
Missoula, Montana**

November 1997

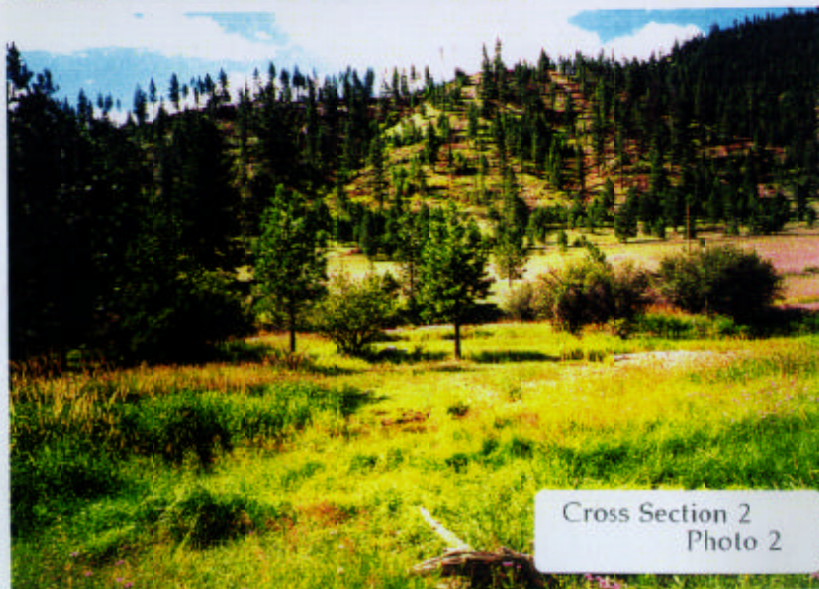
Cross Section 2
Photo 2

From LP. MP is just beyond short (~2') shrub in photo center to left of PINPON and to the right of the downed log in shade of larger shrub. Photo taken along the line of vector C.
